## Elliott provides expander solution where others fell short

Oil Refinery - Fluid Catalytic Cracker Process (FCC), Texas

Non-Elliott Expander

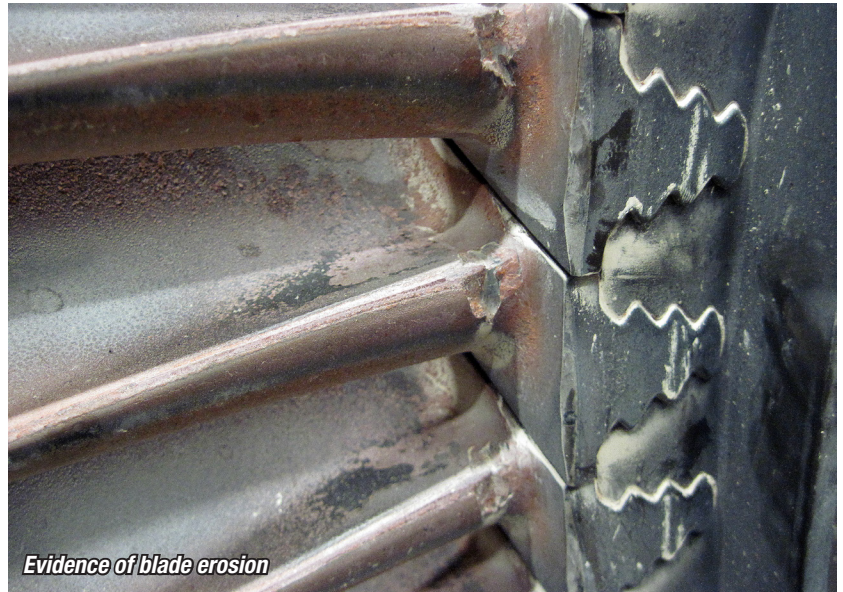
Customer experienced primary and secondary blade erosion, and significant vibration issues with both the equipment and the process piping.

*Evidence of blade erosion*

- ♦ Secondary erosion from small particles entrained in the gas
  - Caused by flow separation and vorticing
  - Disruption of process flow by steam injection

Elliott replaced the inlet and internal expander components with Elliott designed components, redesigned a new base-plate, and recommended modifications to process piping.

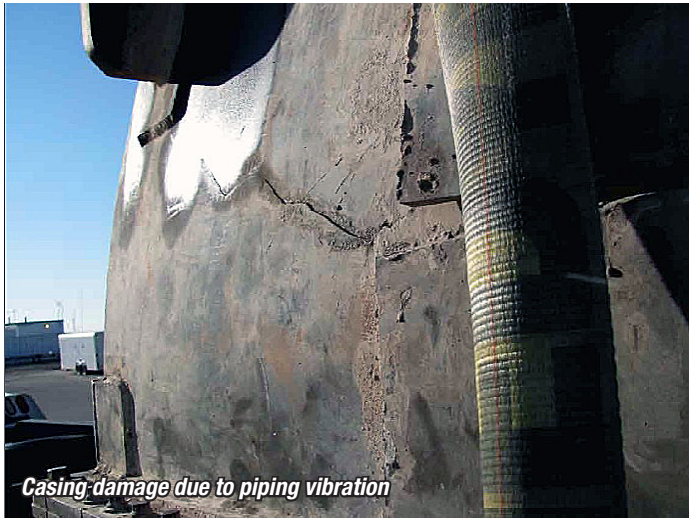
The walk-through revealed that the vibration was located in the process piping, not the expander itself. The entire tower around the process piping was shaking due to acoustic vibration caused by an upstream valve which was nearly closed. This acoustic vibration had caused a crack in the expander exhaust casing.

*Casing damage due to piping vibration*

- ♦ Vortex shedding (turbulent flow) from the inlet valve impacting the process piping
  - Expander was “oversized” causing throttling on inlet valve
  - Large pressure drop (45 psi – 24 psi) across the inlet control valve generating vortices
  - Improper support of piping structure
  - Close proximity of control valve to elbow

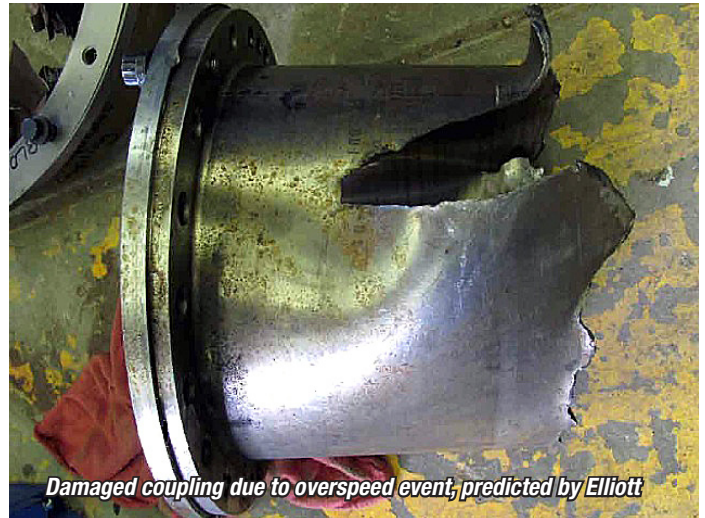
While the customer was reviewing Elliott’s recommended options the expander experienced an uncontrolled overspeed event due to a broken coupling. Elliott’s prediction of this unfortunate event provided credibility to the analysis. The customer invited Elliott back to the site to provide a firm quote for the second option.

*Damaged coupling due to overspeed event, predicted by Elliott*
