## Pre-Owned Blower Rerate Restores Production to Normal Capacity at Canadian Refinery

Oil refinery and chemicals facility  
Alberta, Canada

Blower

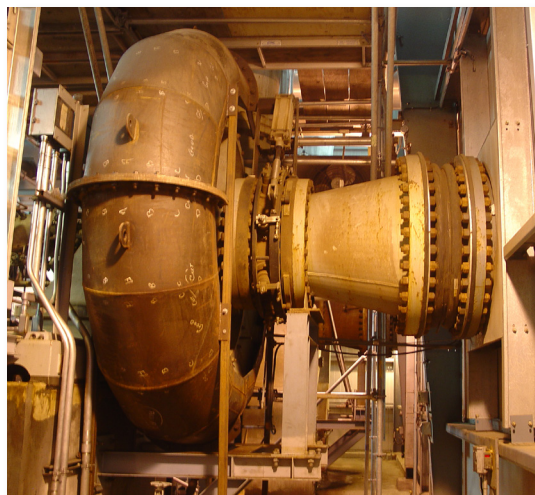
*Failed blower at the refinery.*

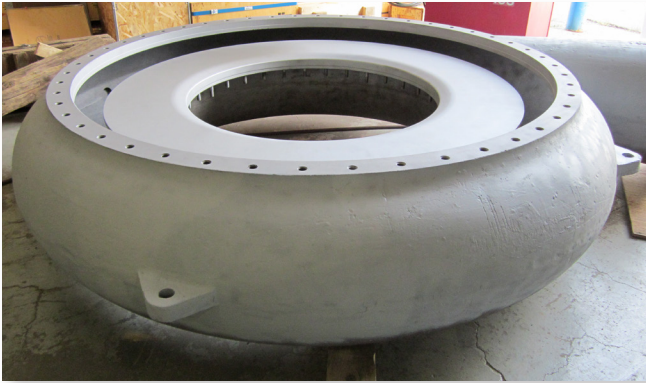
*Refurbished casing after hydrotest and blast cleaning.*

The Edmonton service center inspected and tested the casing of the pre-owned unit to validate the integrity of the metal, using a combination of non-destructive tests and a hydrotest performed to American Petroleum Institute (API) standards.

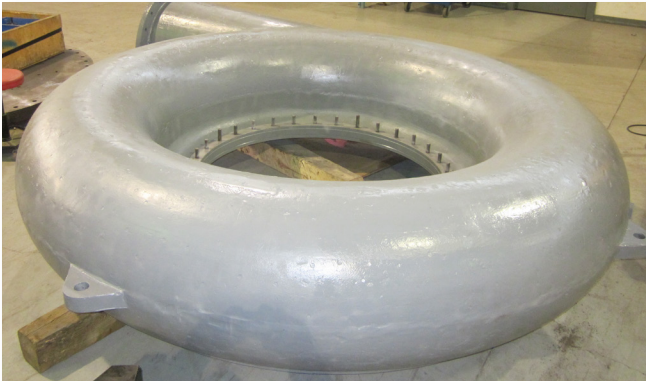
*Painted casing ready for final assembly.*

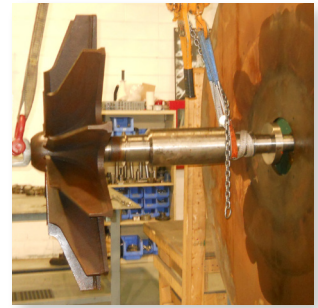
Elliott engineers evaluated the pre-owned compressor at the Edmonton service center and determined that the rotor assembly, consisting of a two-piece impeller design, could not operate at the refinery's desired speed.

*Damaged rotor assembly from the failed blower.*

The Edmonton shop machined a new rotor shaft from AISI 4340 steel to meet the blower's temperature requirement of -40°C; Engineered Solutions designed a one-piece impeller that was fabricated in the Jeannette factory using the same material. Jeannette also supplied a new coupling and coupling guard for the unit.

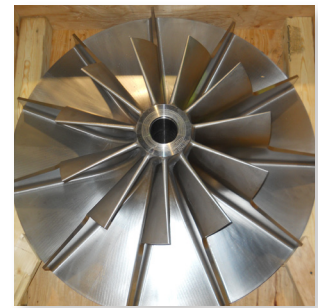
*New one-piece impeller manufactured at the Elliott Jeannette, PA facility.*

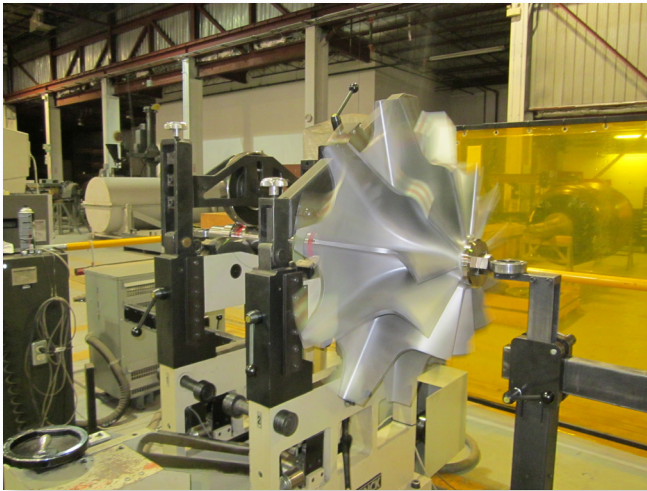
*Rotor assembly being balanced at Edmonton service center.*

The Edmonton service center fit the one-piece impeller from Jeannette onto the new shaft and balanced the final rotor assembly. Elliott engineers then assembled the bearing housing and seal housing from the failed blower, the new rotor assembly, the casing from the pre-owned compressor, and the new backing plate. Prior to installation, Elliott modified the baseplate from the failed unit onsite to improve structural rigidity and weight bearing capacity. The rebuilt blower was installed by Elliott Field Service in June 2012, on schedule with the refinery's startup date.

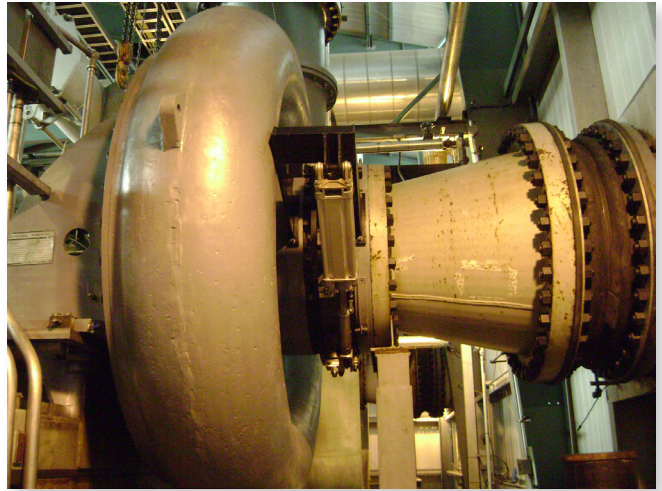
*Repaired blower installed at refinery.*
