## Reapplied Equipment Increases Chemical Plant Capacity

Fertilizer Plant – Sulfuric Acid Process  
Central Florida

Capacity increase in the sulfuric acid  
production process

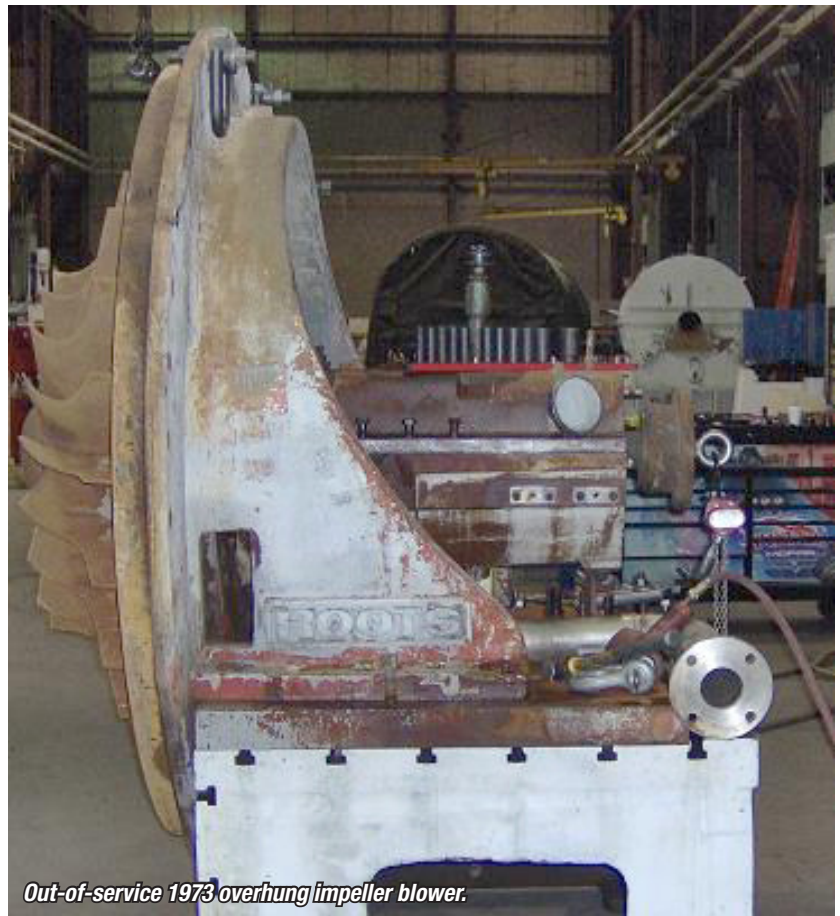
*Out-of-service 1973 overhung impeller blower.*

- ♦ Refurbishing the existing, 1973, 54-inch overhung impeller blower
- ♦ Sourcing and rerating a suitable steam turbine and spare rotor
- ♦ Sourcing and rerating a suitable lubrication system
- ♦ Providing a new baseplate and coupling for the equipment string

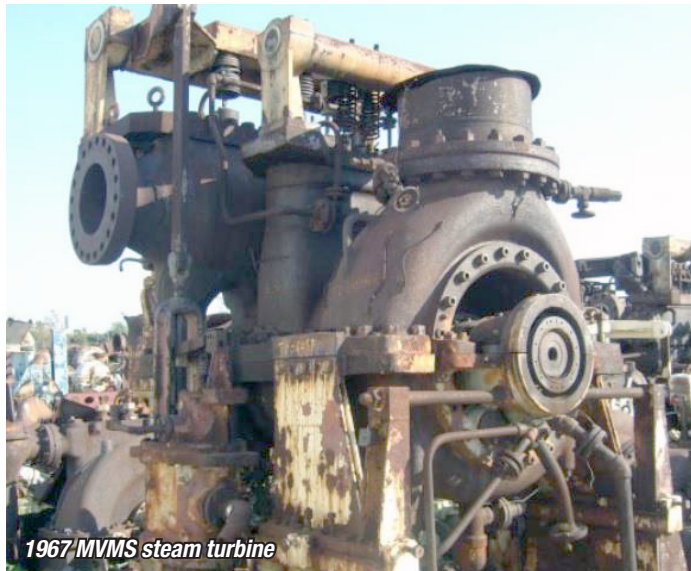
The MVMS turbine required significant modification for its new service. Rotor dynamic analysis confirmed that the turbine would be running on the first critical speed. A critical speed occurs when the rotational frequency matches the rotor's natural frequency, resulting in an amplification of noise and vibration. The turbine was originally rated for 9,656 hp at 6,730 rpm. The blower it would drive required only 5,200 hp at 4,350 rpm.

Elliott made several modifications to ensure that the turbine would meet the new operating conditions:

- ♦ Reduced main shaft diameter to adjust the first critical speed
- ♦ Eliminated one of five inlet valves
- ♦ Plugged portions of the turbine nozzle ring
- ♦ Removed the extraction equipment
- ♦ Installed new journal and thrust bearings
- ♦ Provided new gland condenser ejector package for turbine leak-offs

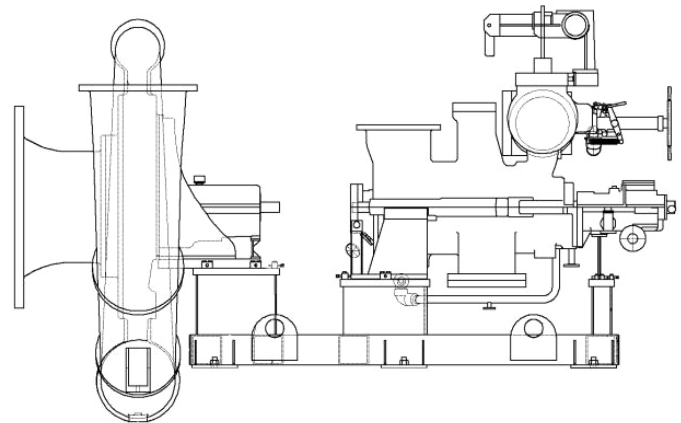
**MVMS turbine-blower skid outline**

Additionally, Elliott Engineered Solutions designed a new baseplate for the equipment string. During the original 30 years of service, the turbine's outline drawing and detailed documentation were misplaced. To ensure that the package was designed accurately, Elliott physically measured the turbine in three dimensions, to locate all major and minor connections. These recorded dimensions were used to re-create the turbine outline drawing and finalize the baseplate and coupling plans.
